INSTALLATION MODIFICATION

RFX-8102 – AM FM ST / CD Player / CD Changer Controller

RFX-8103 – AM FM ST / CD Player / CD Changer Controller / IR Remote

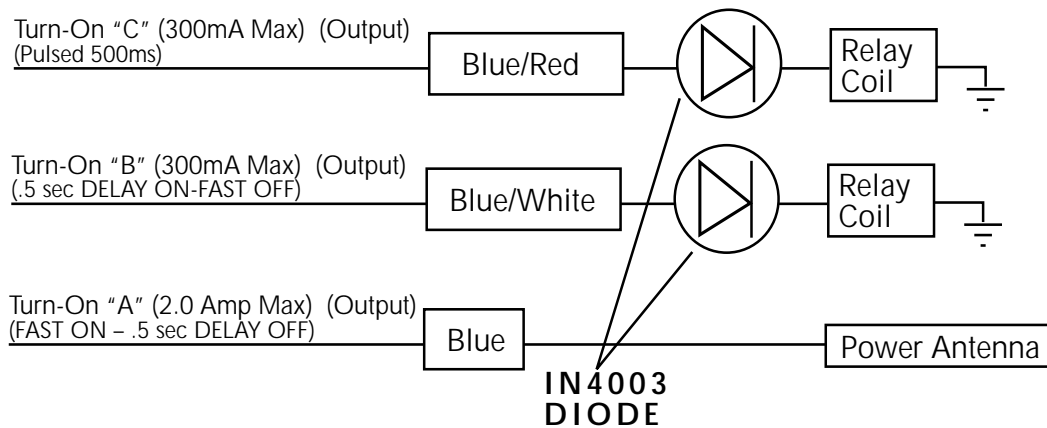
Possible power up failure on the *Multi High Side Driver IC* can occur when connecting Turn-On "B" or Turn-On "C" wires to inductive loads. Activating inductive loads such as relay coils or power antennas can produce reverse voltage spikes. These voltage spikes can feed back into the source unit and possibly damage the *Multi High Side Driver IC*. To prevent this problem from occurring, connect a diode in series (in-line) with Turn-On "B" and "C". **This modification applies only to Models RFX-8102 and RFX-8103.**

- **Turn-On "C"** (pulsed 500ms) Connect to relay system with in-line Diode
Recommend Diode IN4003 (Radio Shack #276-1102)
- **Turn-On "B"** (delay on/fast off) Connect to relay system with in-line Diode
Recommend Diode IN4003 (Radio Shack #276-1102)
- **Turn-On "A"** (fast on/delay off) Connect to Power Antenna
